HOME INSPECTION REPORT

May 2, 2018

Prepared by Kyle Kaufmann

KAUFMANN CONSULTANTS, LLC

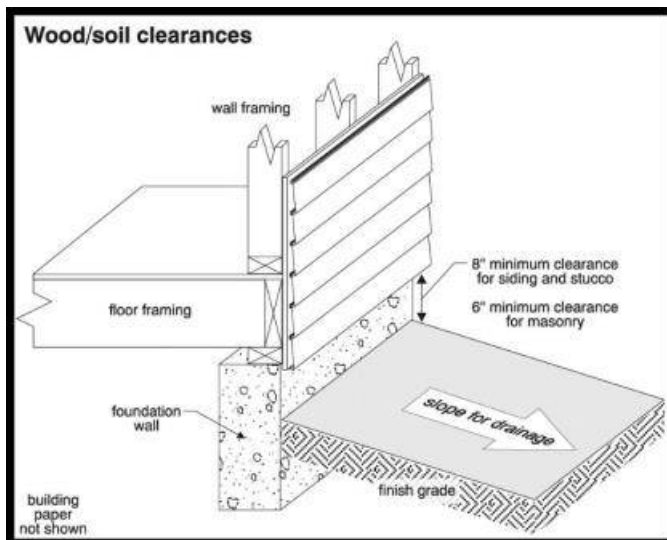
2.2 SOIL CONTACT WITH EXTERIOR SIDING

The siding is in contact with or installed below grade level/mulch. This condition commonly causes rot and is highly conducive to wood destroying insect (primarily termites and carpenter ants) infestation/damage. Our inspection for wood destroying insects was severely limited due to this condition. Damage, which may have resulted from this condition, should be repaired prior to closing. Many buildings with no ground clearance have hidden wood destroying insect infestation/damage that a competently performed wood destroying insect inspection may not disclose under these conditions. Have the soil/mulch removed to expose the foundation. There should be at least 6-8" of clearance between the siding and the ground/mulch. In addition, failure to maintain the grading adequately sloped away from the

foundation could lead to water in the structure. The exterior grade should be a minimum of four inches (8" is even better) below the top of the foundation. Soil above the level of the foundation should be avoided if at all possible as this too can result in rot of wood and wood destroying insect infestations.

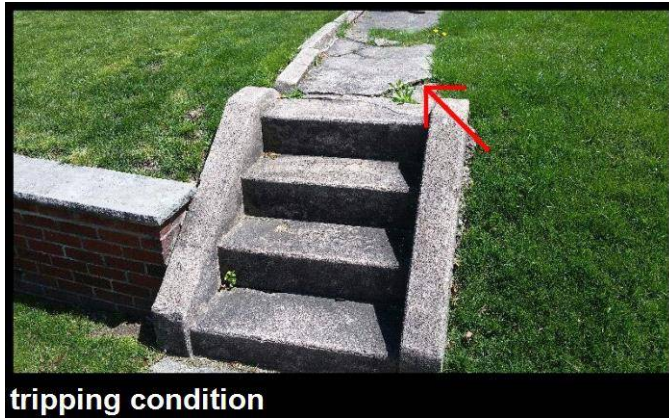
2.9 STEPS

The exterior steps are in some aspects, unsatisfactory condition. Deficiencies include, but are not limited to; There is cracking masonry; which represents a tripping condition that should be repaired.

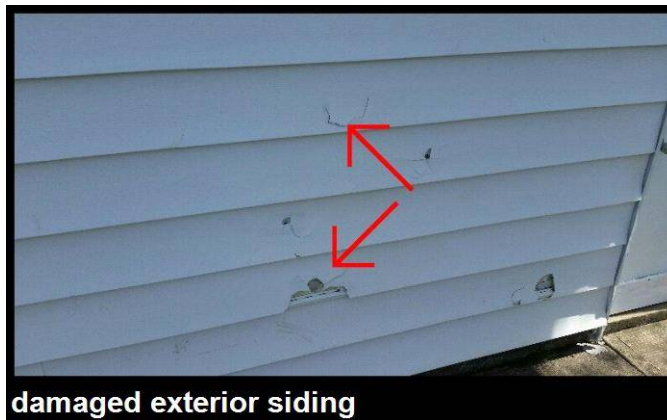
3.2 SIDING CONDITION

The exterior wood clapboard siding is in need of maintenance/repair, which represents a possible "material defect." Deficiencies include, but are not necessarily limited to the following; There is some rot of the exterior siding. The extent of the damage through the wall system is un-determined. There is paint peeling. Have the exterior prepped and re-painted. The exterior vinyl siding is in need of maintenance/repair, which represents a possible "material defect." There is damaged exterior siding; which could result in leakage. There is loose/inadequately fastened exterior siding. A competent contractor should be contacted to more

thoroughly evaluate these "material defects"/conditions and to perform repairs as necessary. NOTE: Vines/vegetation cover much of the exterior. The significance of this condition is; this limits the inspection. A competent contractor should be contacted to trim the vegetation as necessary. A re-evaluation of the conditions should be conducted when conditions permit (before closing).

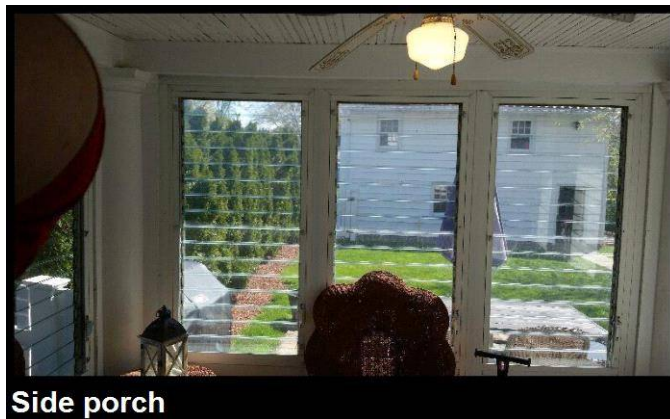
Side porch

The side porch is in satisfactory condition.

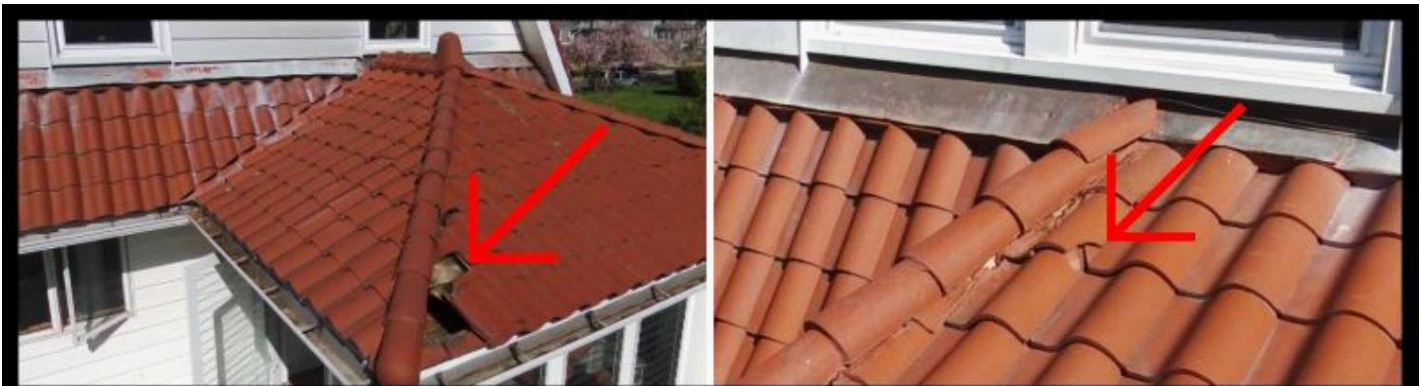
Portions of the roof have been patched indicating problems (leakage). Documentation regarding this repair should be obtained prior to closing and an independent roofing contractor should evaluate the effectiveness of the repair and the need for future repairs. A competent contractor should be contacted to more thoroughly evaluate these "material defects"/conditions and to perform repairs as necessary.

Missing tiles | Cracked tiles

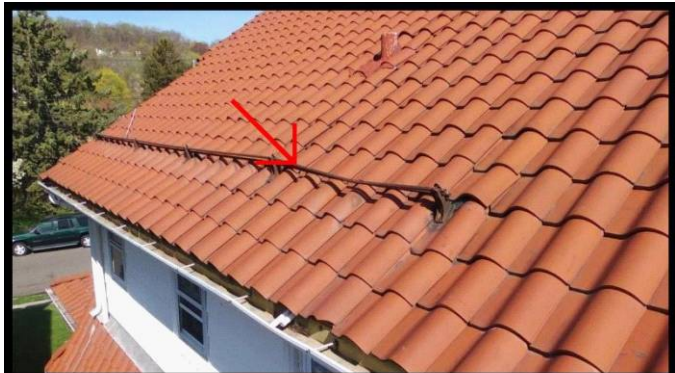
Indications of ice damming

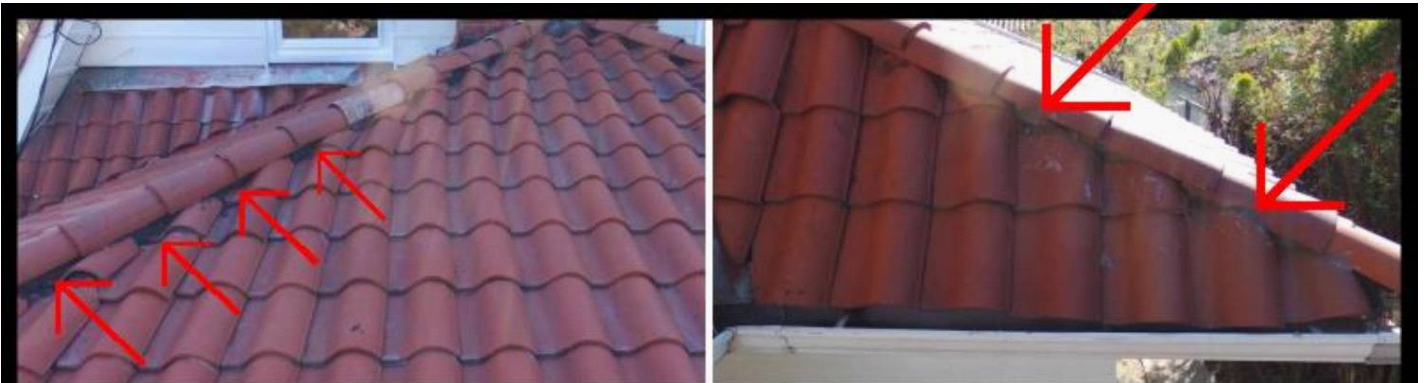
There has been mastic applied to the metal roof system components suggesting past problems. The present homeowner as well as the roofing contractor whom performed the repairs should be contacted to ascertain the scope and nature of the repairs. Anticipate replacement of these metal roofing components.

Mastic indicates prior leakage

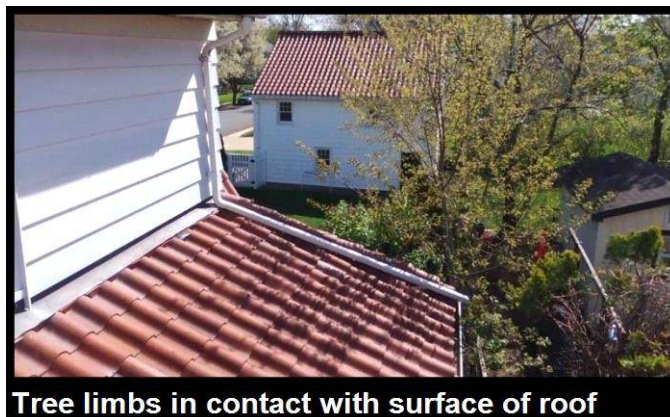
4.9 VEGETATION:

Tree limb(s) observed in contact and rubbing surface of roof. Trim to avoid excessive wear and damage to the roof covering.

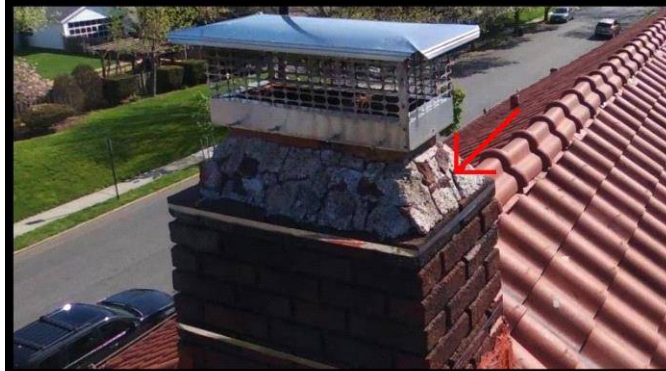
Cracking masonry

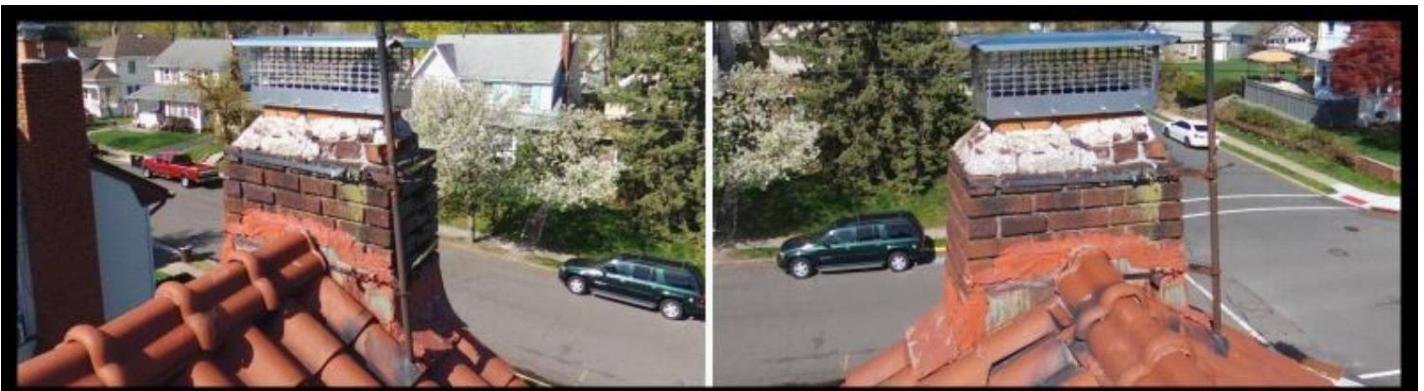
Chimney view | Cracking masonry

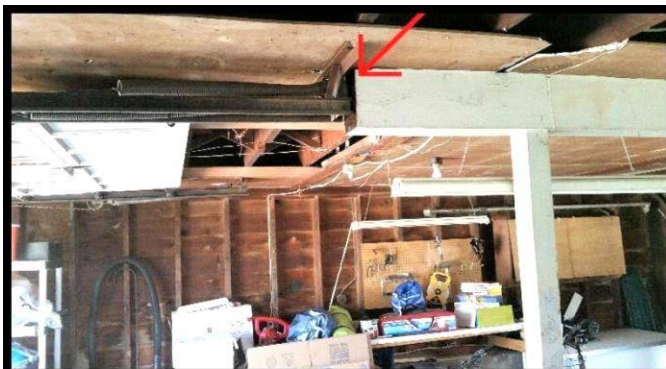
improper framing

caused rot. Contact a competent contractor to evaluate the extent of the defect and the necessary repairs. **There is improper framing of the garage structure; which weakens the structure. The system may not perform as intended or at optimum performance.** A competent contractor should be contacted to more thoroughly evaluate these "material defects"/conditions and to perform repairs as necessary.

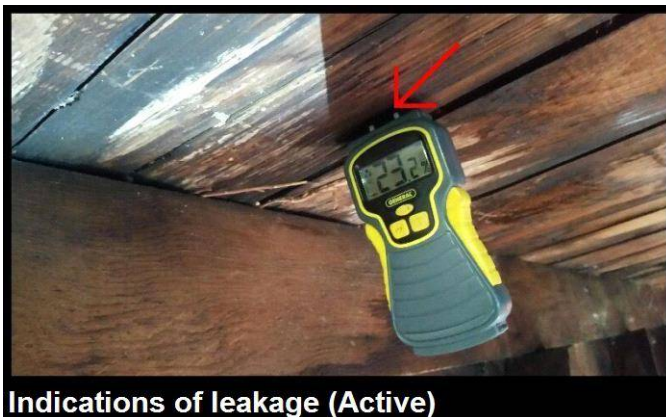
Indications of leakage (Active)

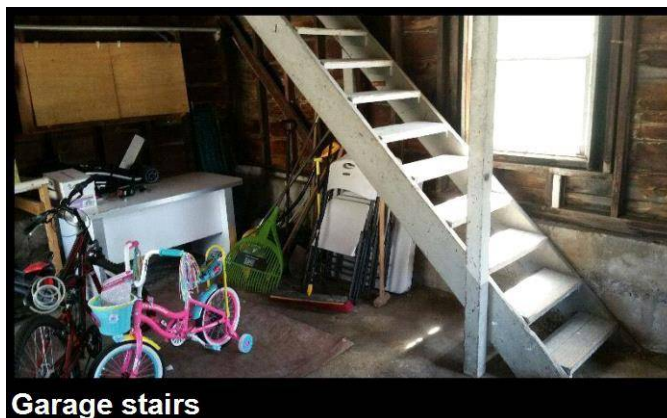
5.4 STAIRS CONDITION:

The steps are in some aspects, unsatisfactory condition. The stringers are separating, which could result in staircase collapse and injury. There are no railings installed adjacent the stairs. This configuration would not comply with modern building standards. The stairs have loose components, which should be repaired. The riser/ tread dimensions are not uniform. The condition would not comply with modern building standards. The condition represents a potential tripping condition. Exercise caution and care when traversing the steps. A competent contractor should be contacted to more thoroughly evaluate these "material defects"/conditions and to perform repairs as

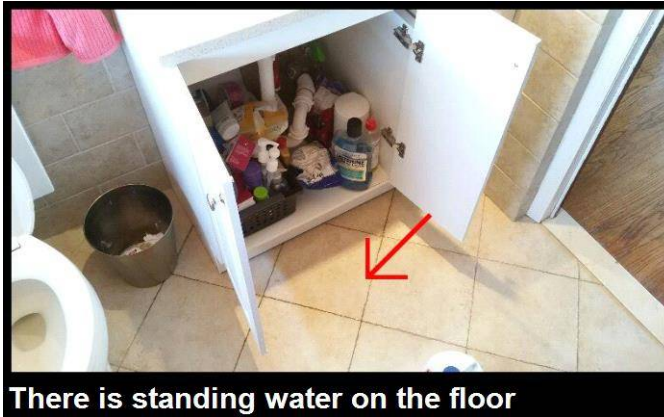
8.4 FLOOR, WALL AND CEILING SURFACES

Floor, wall and ceiling surfaces are in need of maintenance. **There is standing water on the floor.** The condition indicates the need for maintenance. The complexity and the cost of this work is un-determined. The high-gloss floor tiles installed in this room represent a potential slipping condition. Appropriate care and caution should be exercised when exiting the tub/shower area.

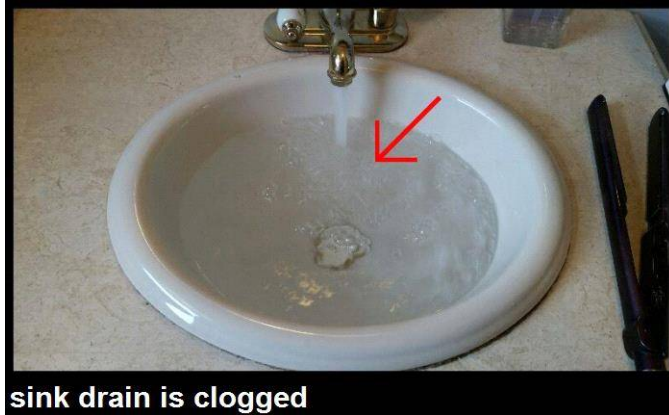
8.11 FAUCET, SINK AND DRAIN LINE

The faucet, sink and drain lines are in need of maintenance. Deficiencies include, but may not be limited to; The sink drain is clogged, which limits the use of the fixture. The flexible accordion drain below the sink should be replaced as this component is vulnerable to clogs. A competent contractor should be contacted to more thoroughly evaluate these "material defects"/conditions and to perform repairs as necessary.

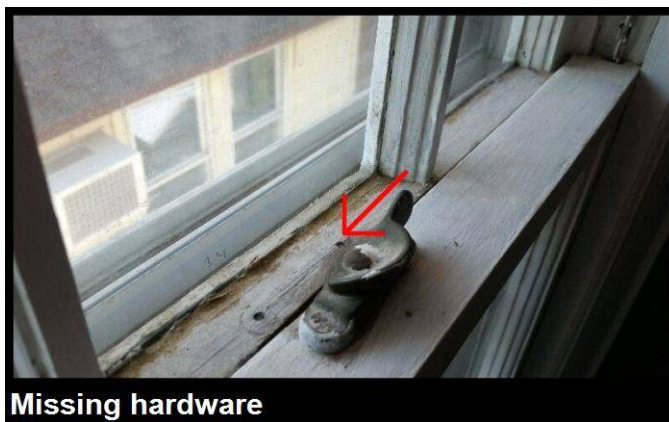
10.6 CONDITION:

The windows are in some aspects, unsatisfactory condition. Deficiencies include, but are not necessarily limited to the following: **Broken/cracked window(s) were observed.** This is common in older homes with single pane glass. The cracks normally do not result in significant heat loss and for this reason, are left "as-is" frequently. Replacement is easy and relatively inexpensive. **Some windows are stuck in the closed position rendering them inoperable.** This may create a safety concern regarding egress. Sometimes this occurs when the windows have been painted in the closed position. Windows should be restored to proper working condition. **Some window sash cords/chains**

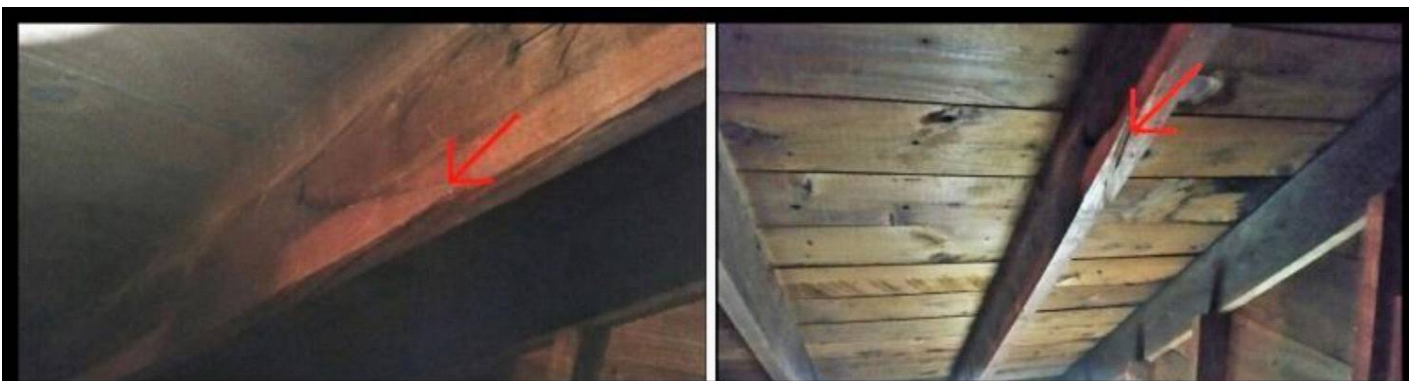
The attic appears to be in some aspects, unsatisfactory condition. Deficiencies include, but are not limited to the following; **There is rot of the roof sheathing.** Areas of damaged sheathing should be repaired or replaced as necessary to preserve the integrity of the roof. **There is a cracked rafter, which should be repaired.** The roof system framing includes 2X8@24 (or greater span)OC (on center) This configuration is common in older homes and generally proves to be adequate, but would not comply with modern building standards. There is considerable storage in the attic limiting the inspector's ability to fully check the area. A re-evaluation of this condition should be performed when conditions permit.

Cracked Rafter

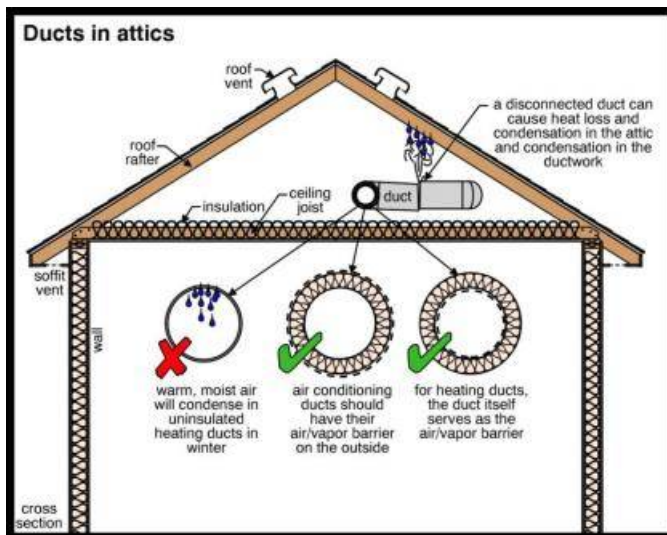
11.10 DUCTWORK:

The insulating material on the flex ducting does not cover portions of the metal register box. This shortcoming may allow cool conditioned air to form condensation on the metal box during the warm, summer months and possibly allow warm conditioned air to leak during the colder winter months. Have the insulation properly installed for improved efficiency and to alleviate potential for water damage. A licensed HVAC contractor could best evaluate the condition. HVAC ducts are loose and leaking in the attic area. The condition indicates the need for maintenance. The complexity and the cost of this work is un-determined.

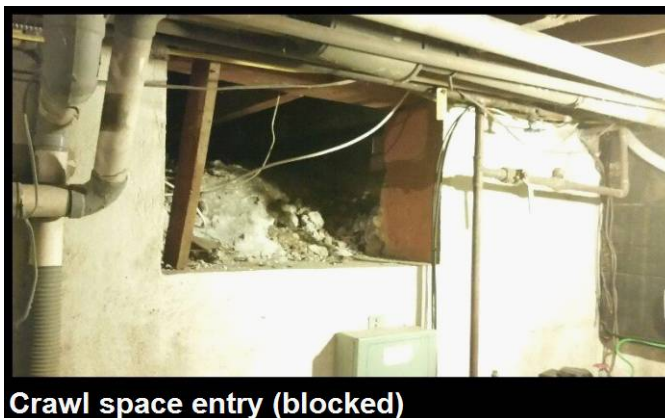
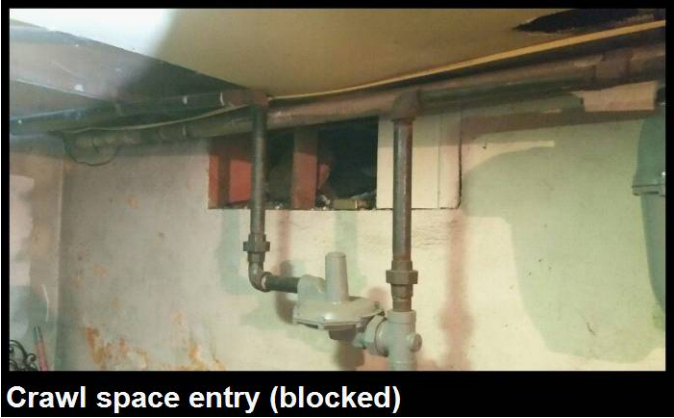
Viewed the right crawlspace area from the entry hatch with a high powered light. Current standards for entering and inspecting a crawlspace are 24" vertical clearance and 30" width clearance. This limitation is for the safety of the inspector and also does limit the ability of the inspector to check all areas in the crawlspace. Under some conditions, access can be easily improved and a more thorough evaluation can be made. Improve access so a proper inspection of the area can be performed. There is limited access and visibility of the areas due to; The entry being too small for safe entry and movement, inadequate clearance under/around the framing, insulation, muddy/wet conditions, which could be hazardous to the inspector, and the presence of suspected asbestos, which could pose a hazard to the inspector. The significance of the limitation is that some areas could not be viewed or inspected. Access to these areas should be provided so that an inspection can be done prior to closing. This access should include at least 24" vertical and 30" horizontal clearance.

Crawl space entry (blocked)

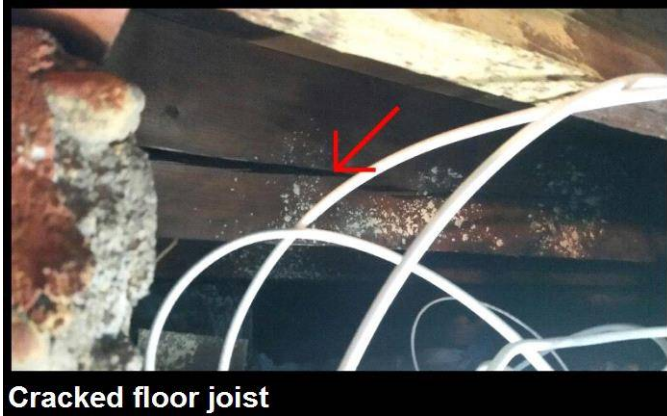
Cracked floor joist

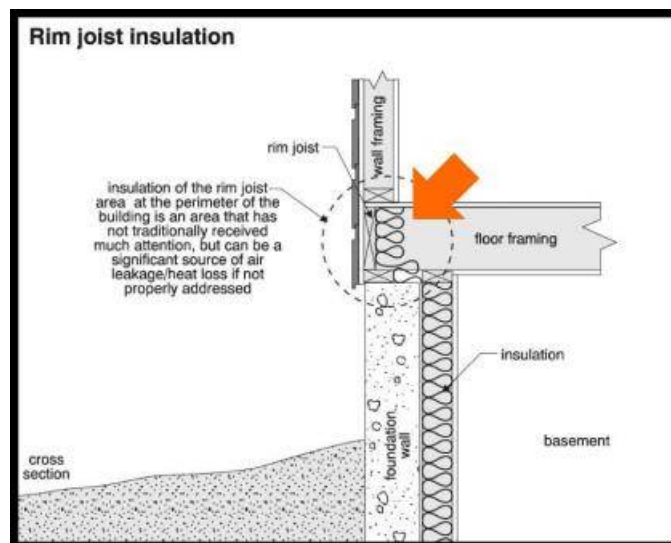
12.15 MAIN FLOOR INSULATION:

The perimeter of the basement area is insulated along the box beam area, which is consistent with building standards in this region. This is beneficial. The insulation does restrict the inspectors' ability to view the adjacent structural framing that is concealed by the insulation. Some of the perimeter insulation has been removed to install telephone, cable and electric cables. The insulation should be re-installed for improved thermal efficiency.

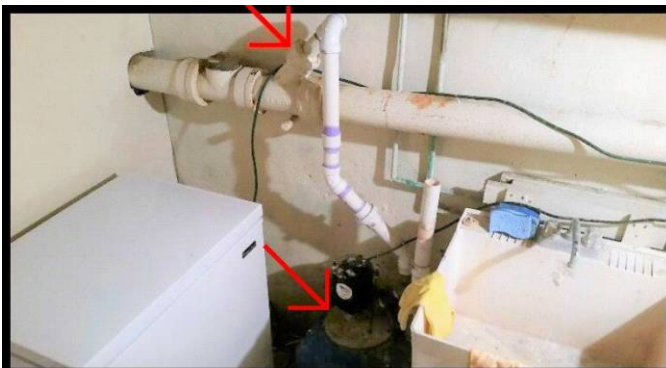
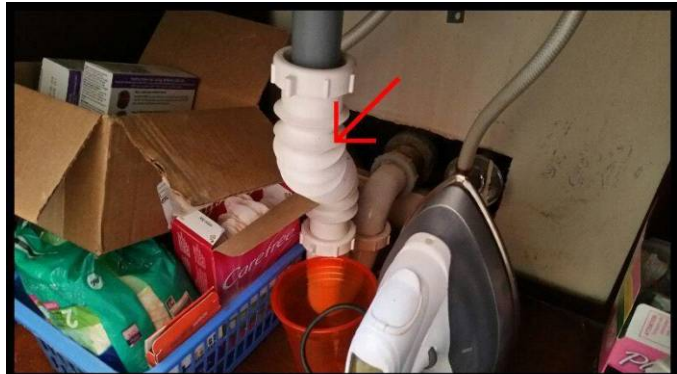
The plumbing system is in unsatisfactory condition. Deficiencies include, but may not be limited to the following; There are leaky plumbing fixtures. There are amateur installations, which may prove to be un-reliable. The plumbing system is older, but has been partially upgraded. Future upgrades and repairs should be anticipated. Consideration should be given to obtaining bids from a licensed Plumber to upgrade the home's plumbing system.

amateur installations

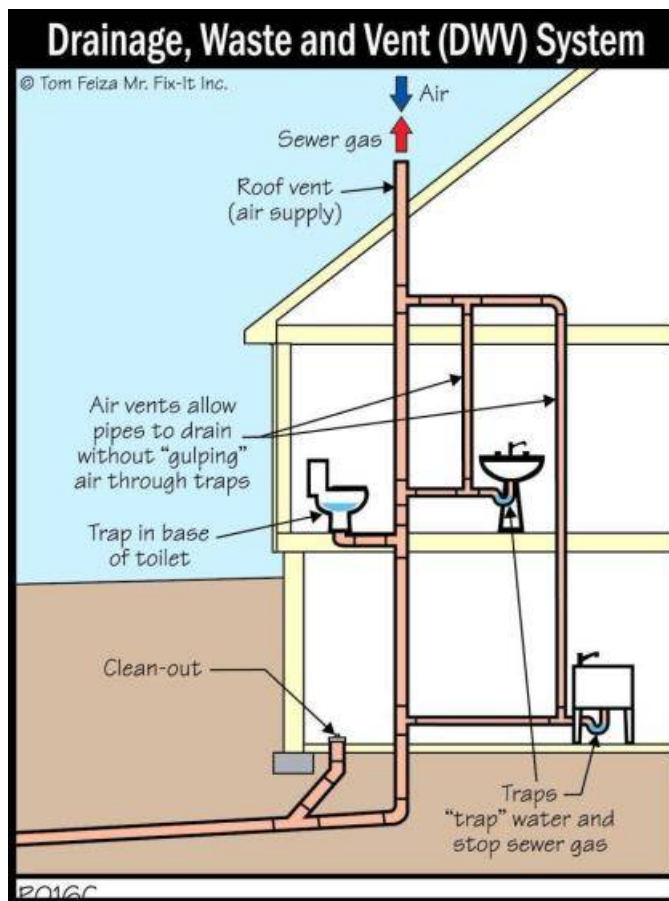
13.7 WASTE PIPE SYSTEM:

The plumbing system includes; PVC, ABS (plastic), lead, galvanized, and iron piping. The waste piping appears to be in some aspects, unsatisfactory condition.

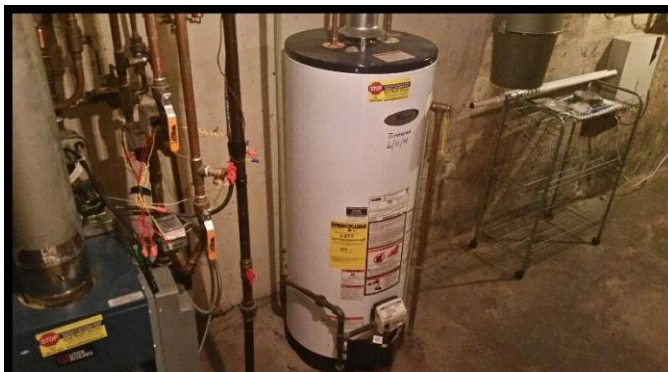
The water heater is in some aspects, unsatisfactory condition. Deficiencies include, but are not necessarily limited to the following; The pipes coming to the unit are corroded indicating a past/present leak. Replacement is recommended.

Water heater

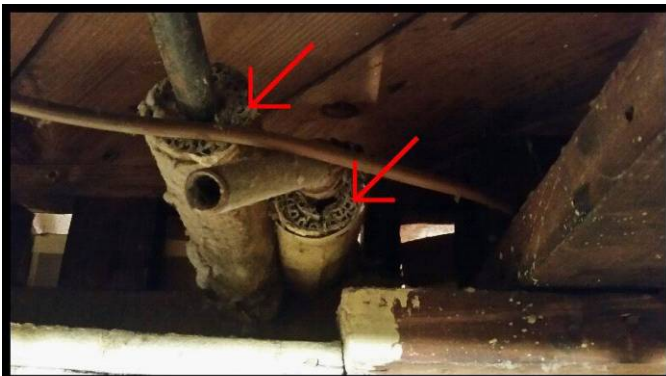
The boiler (heating system) is in need of maintenance. Deficiencies include, but are not necessarily limited to the following; The old pipes have suspected asbestos insulating material on them. The amount and extent of the suspected asbestos installation is undetermined. A qualified and licensed asbestos abatement specialist should be consulted to determine whether or not the suspected material is asbestos, the extent to which the material is installed throughout the house and to perform repairs/removal/remediation. NOTE: Asbestos is a controversial installation. Complete information concerning asbestos should be obtained from the NJDEP. Methods and recommendations vary depending upon the application, and may change with time as well. Only DEP officials can provide complete up to date information in this regard. The DEP will also provide a list of certified contractors to implement their recommendations.

suspected asbestos

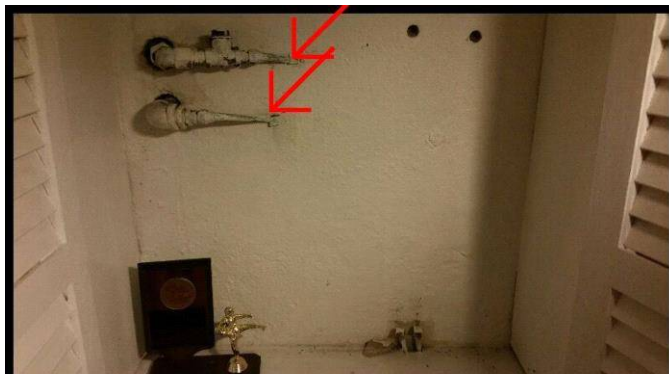
indications of a buried fuel tank

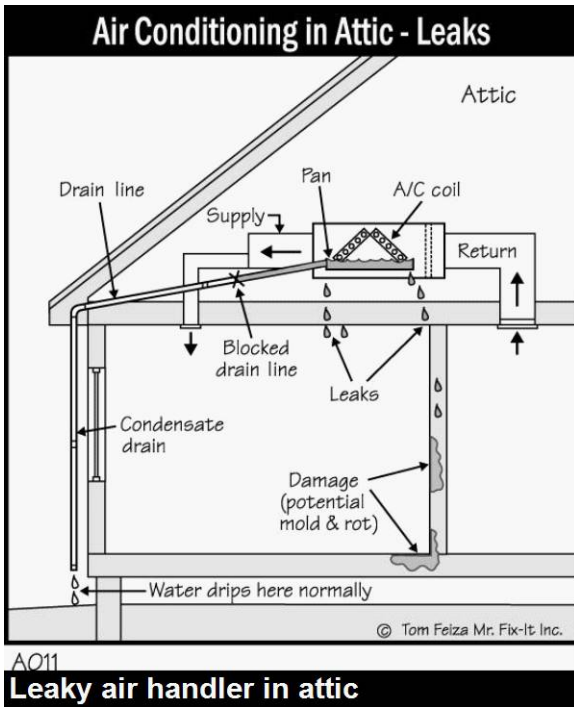
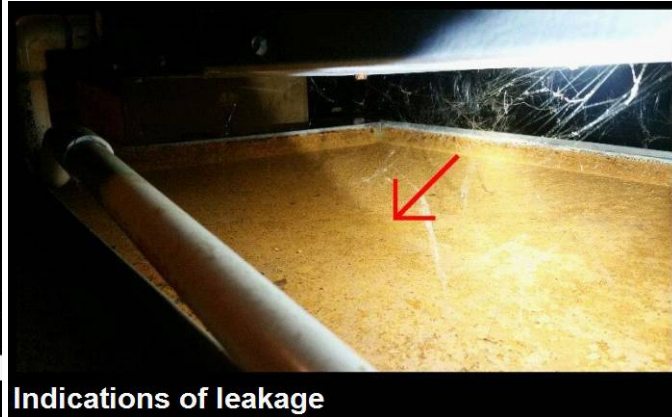
NOTE: The drip pan is back-pitched; which is likely to adversely affect function. Repair is recommended.

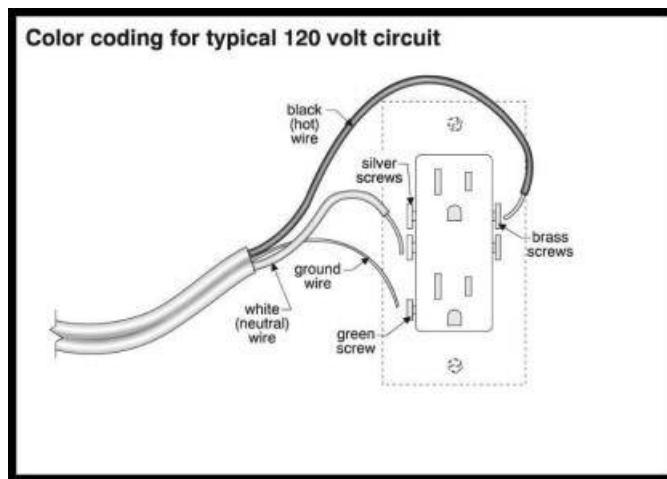
17.9 RECEPTACLE GROUNDING

Ungrounded outlet/s detected, which is considered potentially unsafe. Most outlets installed since the middle 60's have been the grounded type, having three holes for each outlet. Grounding is a reliability/safety feature which is part of the electrical system that should be properly maintained. Where testing of outlets shows no ground connection is present, the problem generally can be traced to a loose wire in the receptacle box or in the electrical panel and sometimes is easily corrected. **In this case, it is possible that the cause of the un-grounded outlets is the use of old, antiquated knob and tube conductors.** Contact a qualified electrician to determine whether or not these conductors are installed. If knob and tube conductors

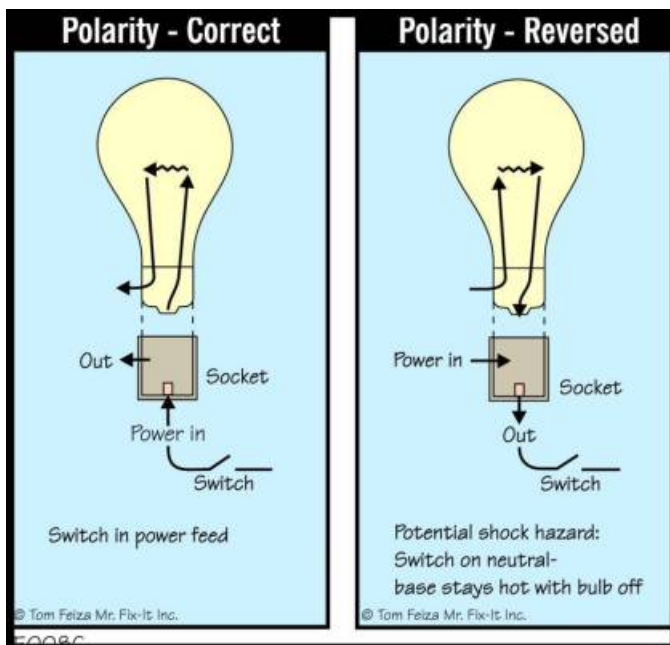
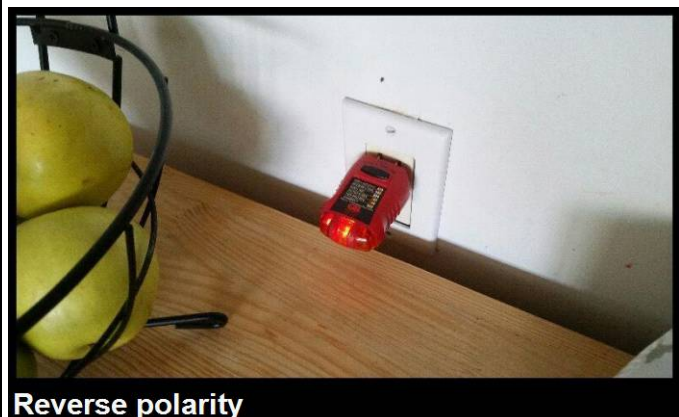
Reverse polarity is detected in outlet/s. Reversed polarity in an outlet is most often due to the improper connection of wires to the outlet itself, and is normally easy to correct. Some electronic appliances sustain damage when connected to reversed polarity outlets. Some locations where reverse polarity outlets are present include, but are not necessarily limited to the following: Kitchen.

Reverse polarity

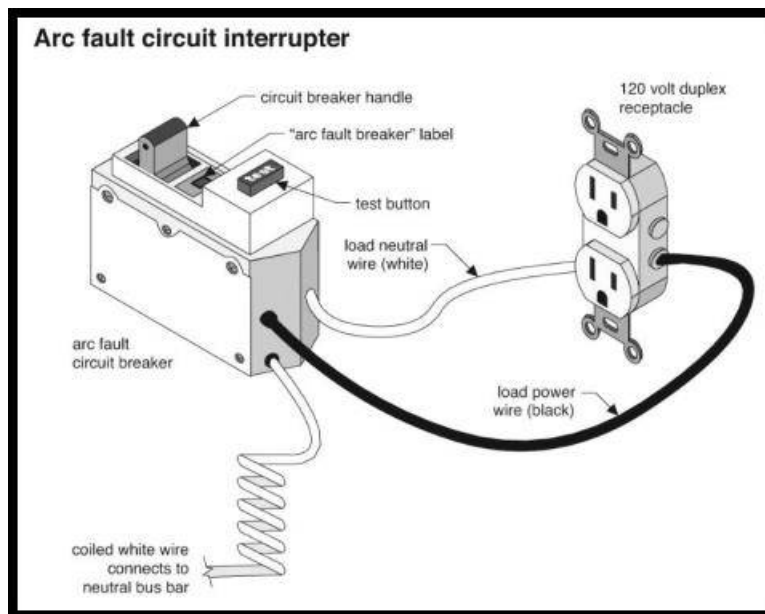
17.13 AFCI PROTECTION:

The electrical system does not have Arc Fault Circuit Interrupter (AFCI) protection. The installation of these safety components may not be required in existing structures, but should be considered as part of up-grading the electrical system and improving safety.
