HOME INSPECTION REPORT

May 2, 2018

Prepared by Kyle Kaufmann

KAUFMANN CONSULTANTS, LLC

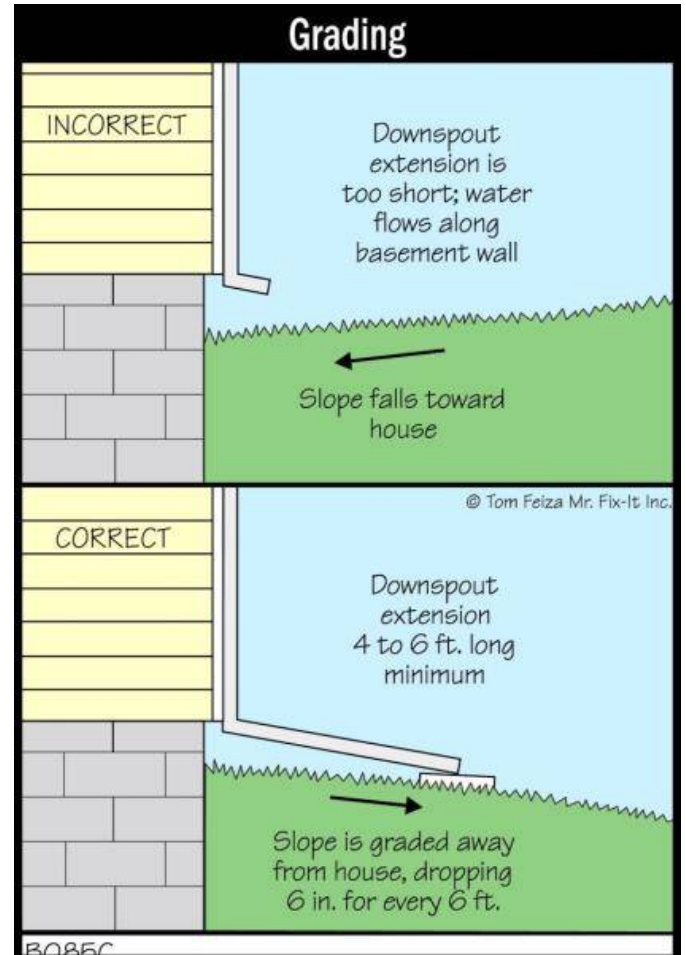
2.1 SLOPE WITHIN 10 FEET OF HOUSE:

Level to Negative grade, which may contribute to a water condition in the basement is noted at the rear. The general guideline is for the grading to drop 6" in the first 6' away from the foundation. This promotes water saturation away from the foundation and lessens the chance for water entry in and under the structure.

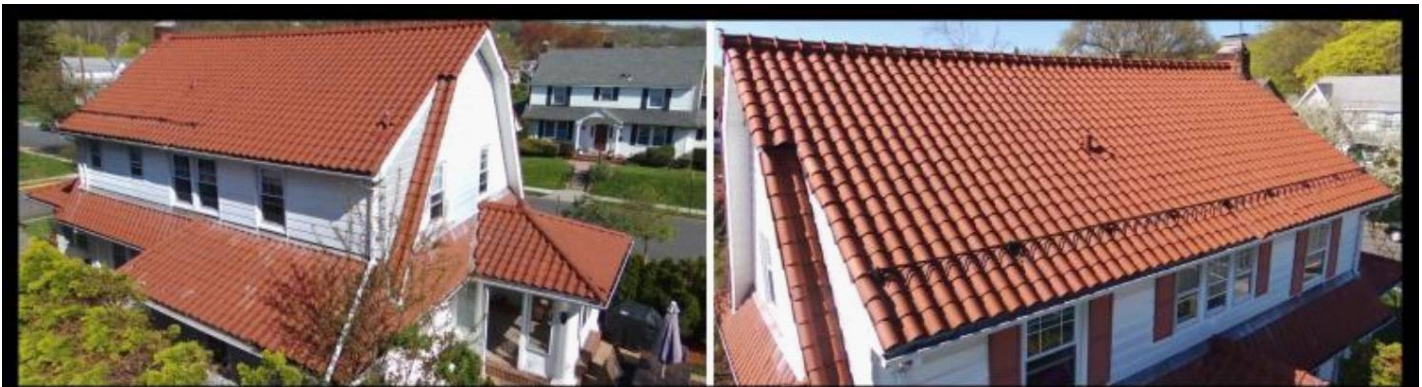
Roof View

The Concrete/clay roofing tiles is in unsatisfactory condition, which represents a possible "material defect." Deficiencies include, but may not be limited to the following; The roof covering also shows signs of excess wear due to exposure. These conditions include, but are not necessarily limited to; Roof tiles are split. This condition may be a reflection of normal wear and tear and could result in leakage. There are missing tiles, which could result in leaks. There is rot along the edges of the roof. One or more of the tiles are cracked at the overlap. It is unlikely a leak will develop due to the tiles underneath, This is considered a cosmetic condition. Repair as desired. There are missing roof tiles at some locations. Replacement is recommended. One or more of the tiles are broken and water intrusion is likely. The best repair is to replace tile, mastics do not have the durability of the tile and is not considered a permanent repair. If tiles are not available, consider replacing the tile with a tile from the overhang where water intrusion is less of a concern. Use mastic to repair the damage tile. This is a suggestion only and your licensed roofing contractor is best able to advise you and make repairs.

Portions of the roof have been patched indicating problems (leakage). Documentation regarding this repair should be obtained prior to closing and an independent roofing contractor should evaluate the effectiveness of the repair and the need for future repairs. A competent contractor should be contacted to more thoroughly evaluate these "material defects"/conditions and to perform repairs as necessary.

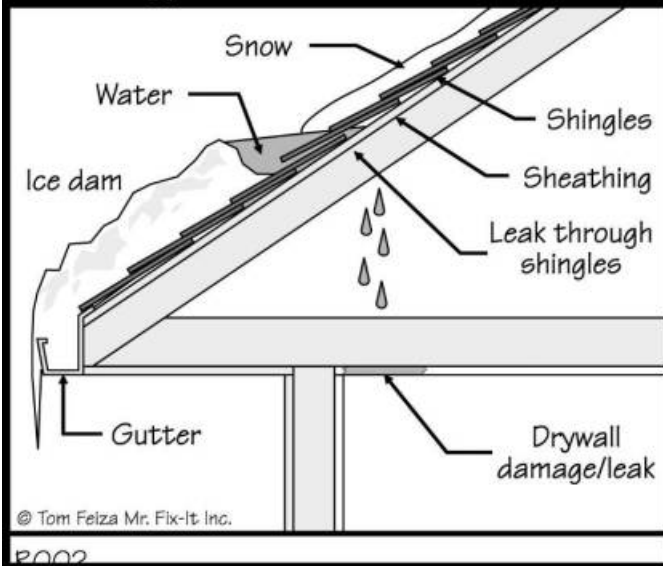
Indications of ice damming

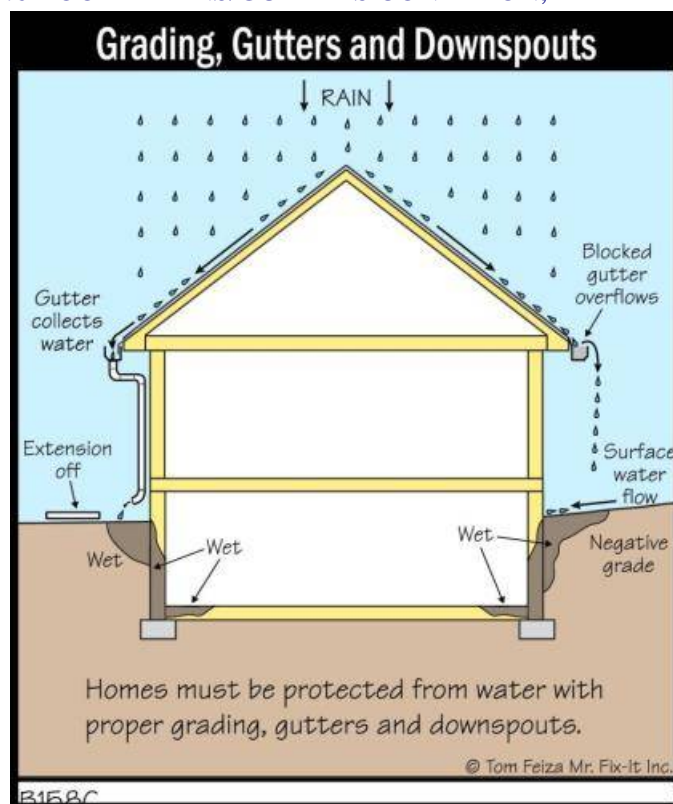
4.6 ROOF DRAINS/GUTTERS CONDITION;

The gutters are in need of maintenance/repair. Deficiencies include, but may not be limited to the following: The gutters are clogged with leaves,

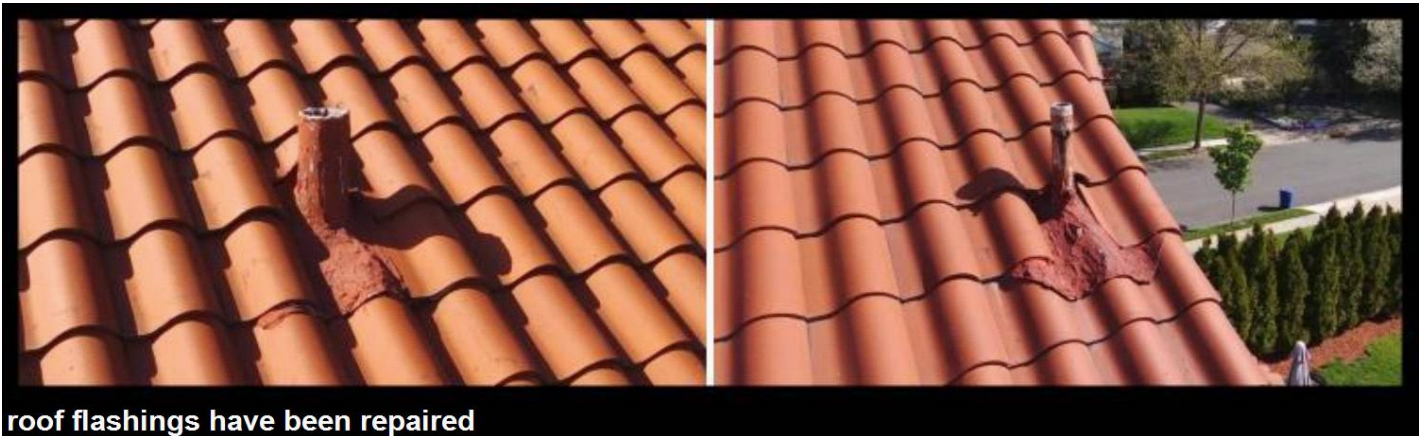
The roof penetration flashings are improperly installed (material defect). This could result in roof leakage. The plumbing vent roof flashings have been repaired indicating some degree of problems at these areas in the past. The nature and scope of repairs should be discussed with the present home-owner and the repairman, who performed the repair. The flashings are rusted due to long-term exposure to the elements. Due to the overall age and condition of this component, a future serviceable life will

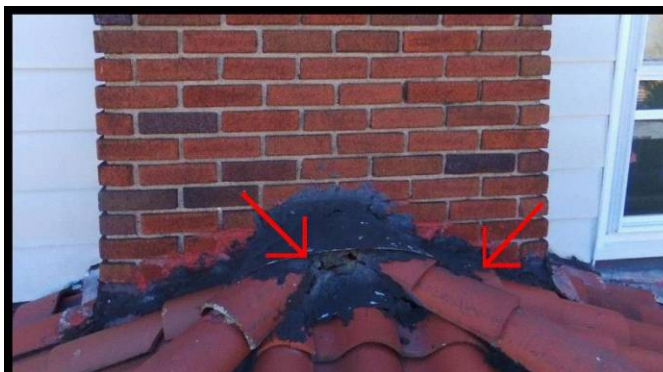
Application of mastic suggest past water intrusion. The nature and scope of repairs should be discussed with the present home-owner and the repairman, who performed the repair.

Indications of past water intrusion

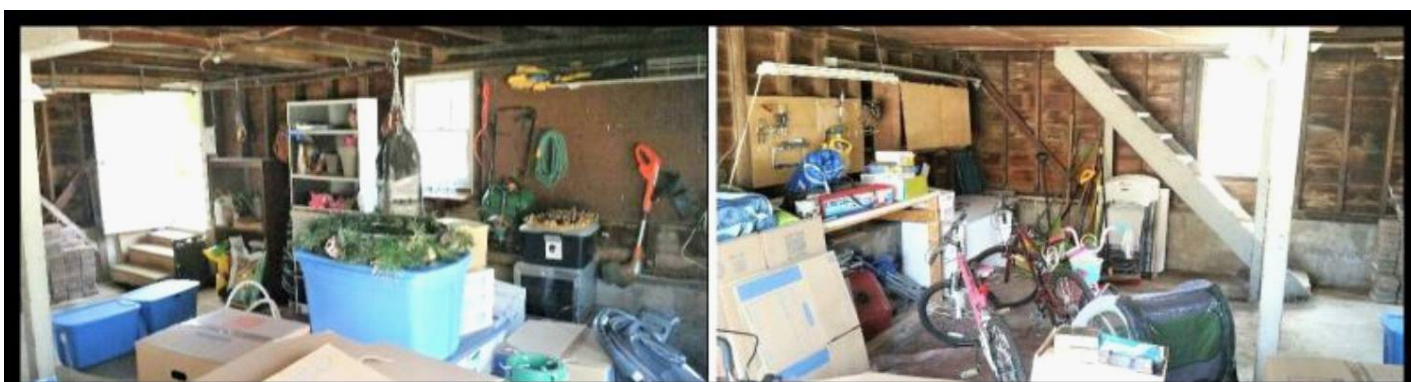
In general, the garage is in some aspects, unsatisfactory condition. Deficiencies include, but are not necessarily limited to the following: There is contact between the garage siding and the soils. This condition has caused rot and probably wood destroying insect (termite) infestations/damage. The windows are in poor condition. Replacement is recommended. There are indications of pests. This is indicated by droppings in the area. Contact an exterminator in this regard. There is cracking of the foundation, which should be repaired. There is apparent water leakage into the garage from the exterior. This leakage has

caused rot. Contact a competent contractor to evaluate the extent of the defect and the necessary repairs. **There is improper framing of the garage structure; which weakens the structure. The system may not perform as intended or at optimum performance.** A competent contractor should be contacted to more thoroughly evaluate these "material defects"/conditions and to perform repairs as necessary.

Personal property prohibits full view

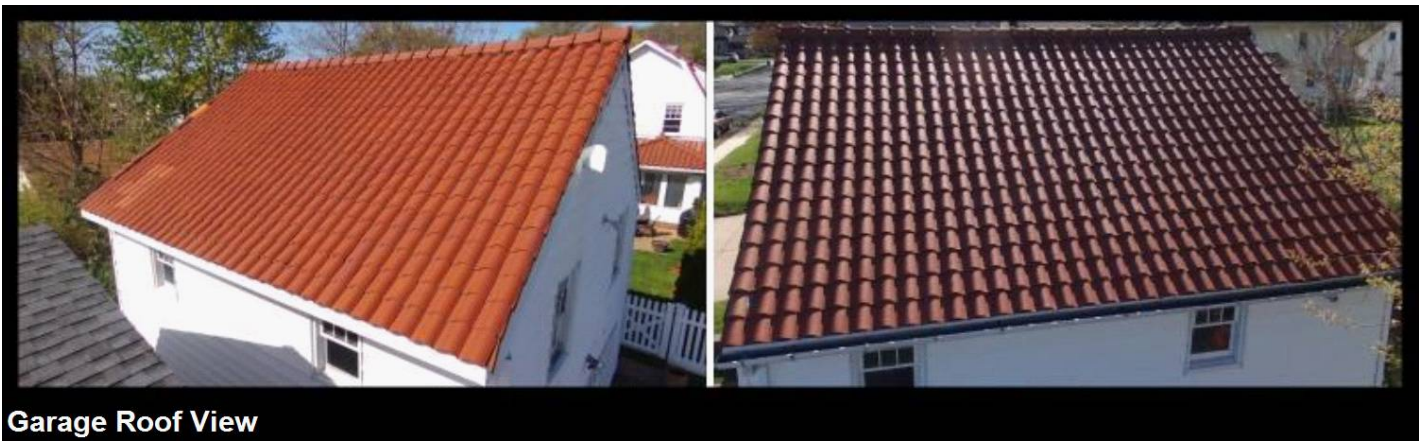
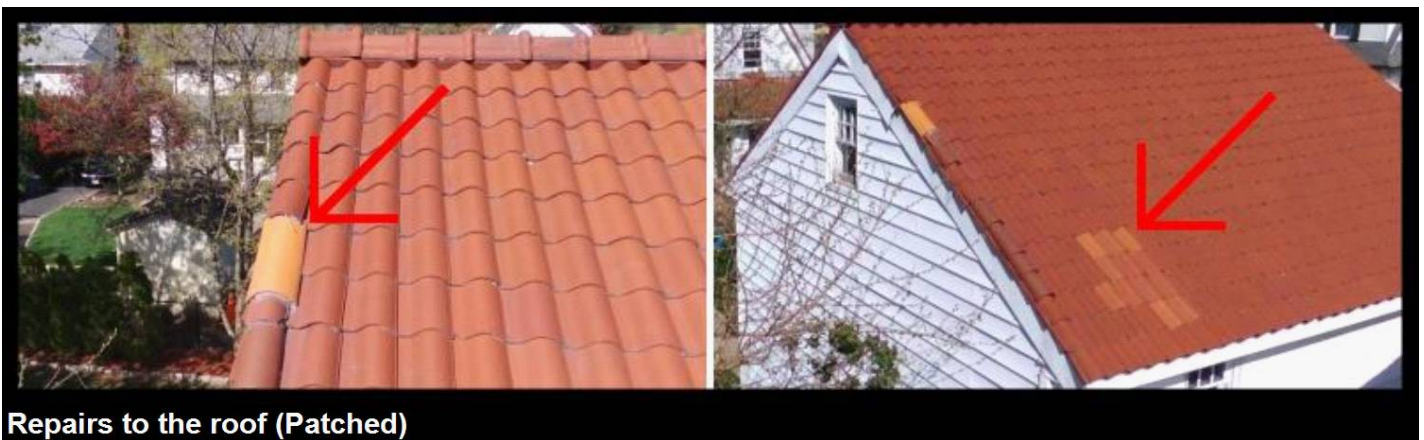
The roofing is in unsatisfactory condition. Deficiencies include, but are not limited to the following; **The roof decking/sheathing is rotted. The roofing on the garage is leaky.** Repair/replacement is recommended.

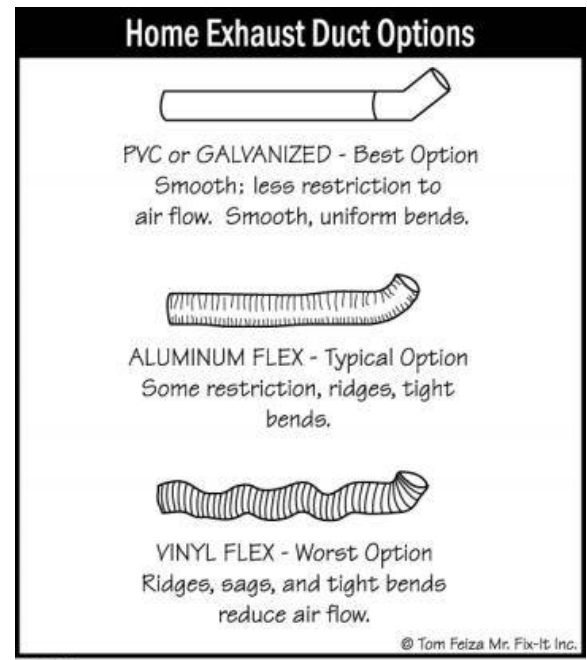
V015

The dryer vent is routed with plastic flex duct. The CPSC stated that plastic dryer vent ducting is a fire hazard and should be upgraded to metal for safety. **FOR YOUR INFORMATION.** There are more fires caused from lint build in the dryer vent pipe than from fireplaces. The long circuitous route taken by the vent makes it vulnerable to clogs. I recommend you check the line when moving in and have it checked regularly. A licensed chimney sweep performs this service.

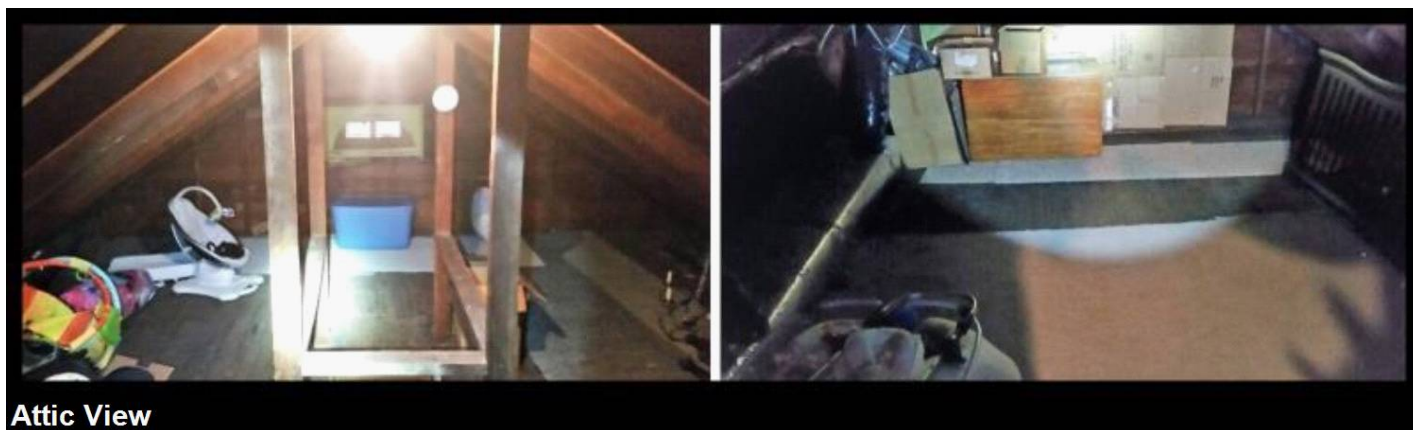
Attic View

The attic appears to be in some aspects, unsatisfactory condition. Deficiencies include, but are not limited to the following; **There is rot of the roof sheathing.** Areas of damaged sheathing should be repaired or replaced as necessary to preserve the integrity of the roof. **There is a cracked rafter, which should be repaired.** The roof system framing includes 2X8@24 (or greater span)OC (on center) This configuration is common in older homes and generally proves to be adequate, but would not comply with modern building standards. There is considerable storage in the attic limiting the inspector's ability to fully check the area. A re-evaluation of this condition should be performed when conditions permit.

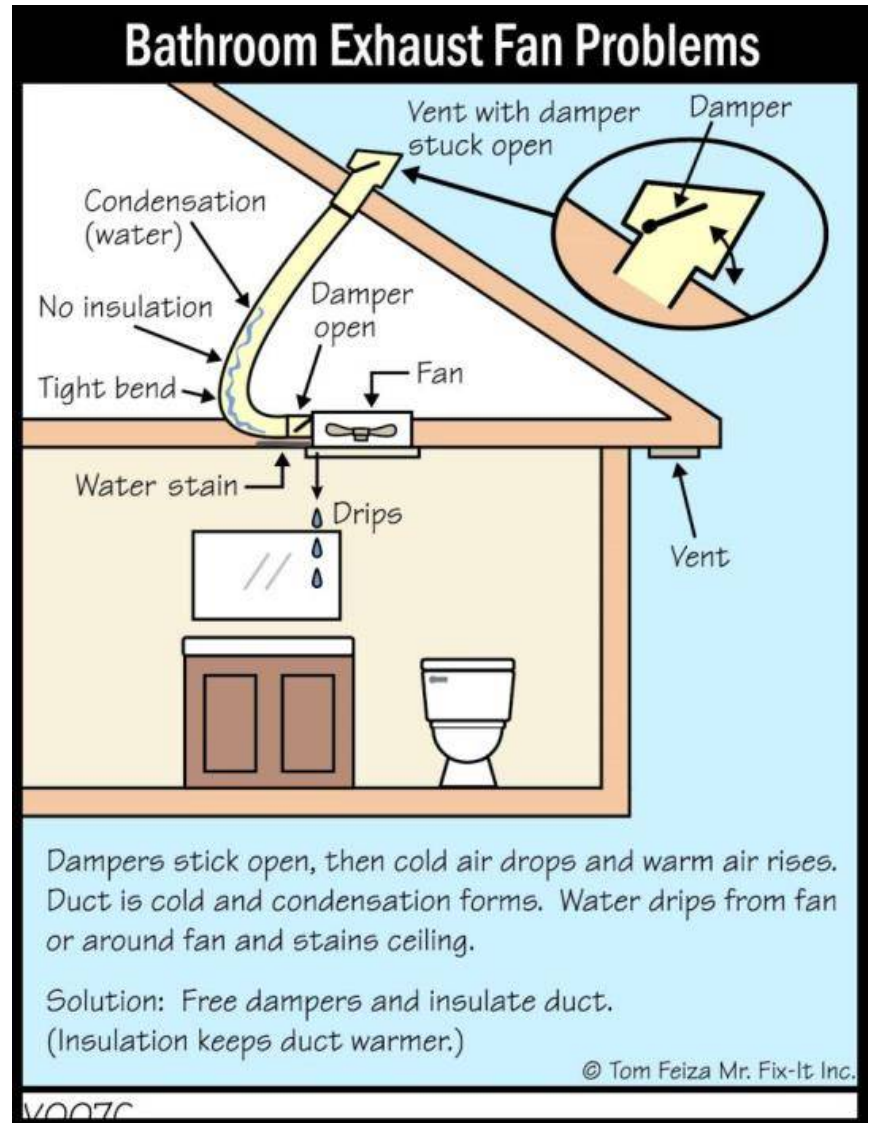
The bathroom vent fan ducts are in some aspects, unsatisfactory condition. The vent duct is un-insulated, which may promote the development of condensation (water) that can block the duct and cause water staining of the ceiling.

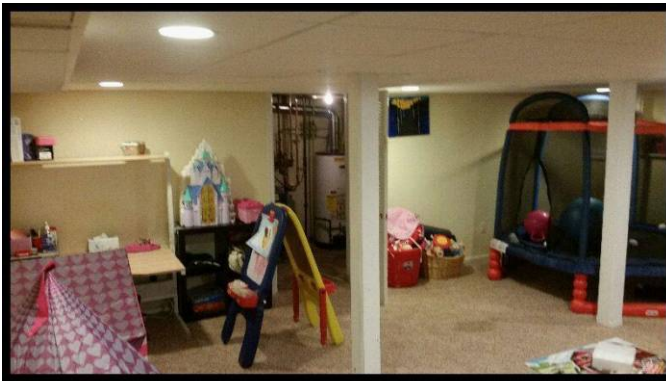
Personal property prohibits full view

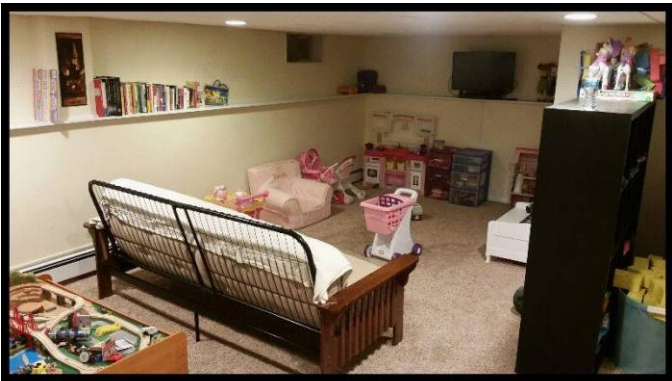
Personal property prohibits full view

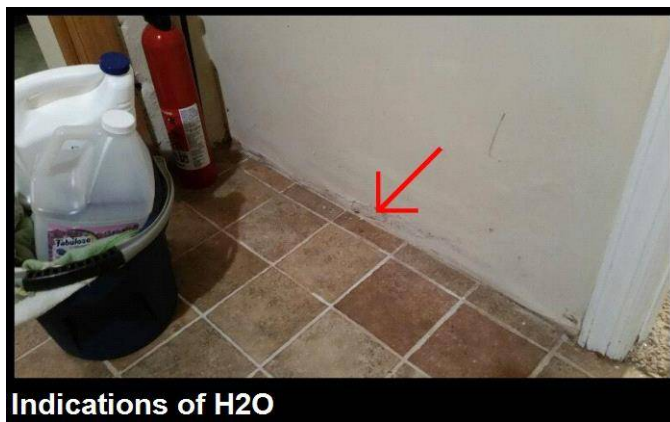
12.16 MOISTURE:

The inspection for water conditions is dependent upon seasonal weather conditions. It is possible that the interior of the home could appear dry during the home inspection, but later develop water conditions. **At this time, there are indications of water leakage through the foundation walls into the basement area, which is a "material defect".** Weather conditions may increase frequency and intensity of leakage. Additionally, water leaks may result in mold forming. Indications are in the form of water stains/efflorescence on the floor/walls and rot of the walls. It is recommended that a water-proofing contractor be contacted to evaluate the condition and

to ascertain what corrective measures are appropriate/necessary.

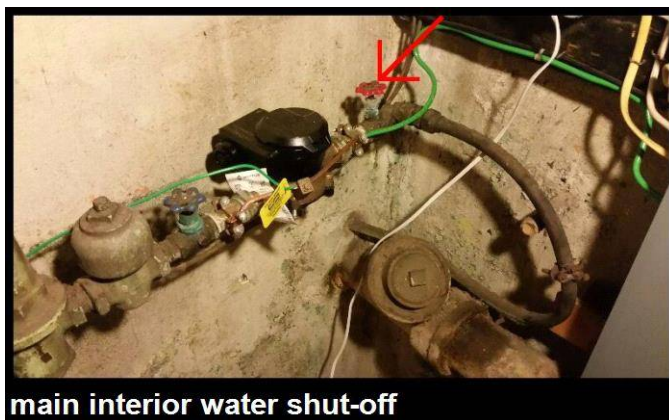
The main interior water shut-off location is inside the front foundation wall. The operation valve handle cannot be checked. These handles have a tendency to leak when operated. This is partially due to infrequent use. The shut off valve (see adjacent photograph) otherwise appears to be satisfactory and is identified with a red handle.

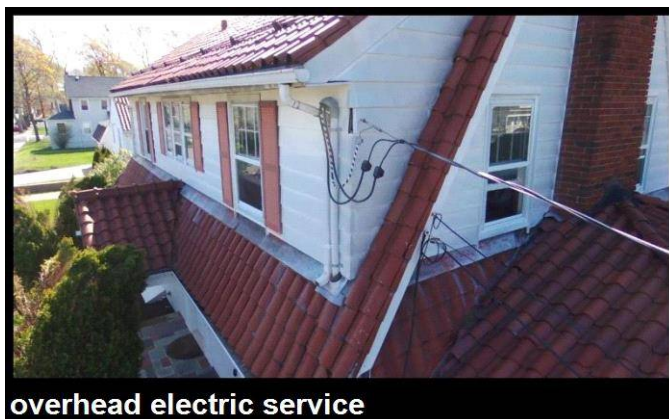
17.1 ELECTRICAL SERVICE:

The home has an overhead electric service and overhead service drop wires have adequate clearance. (see the adjacent photograph)

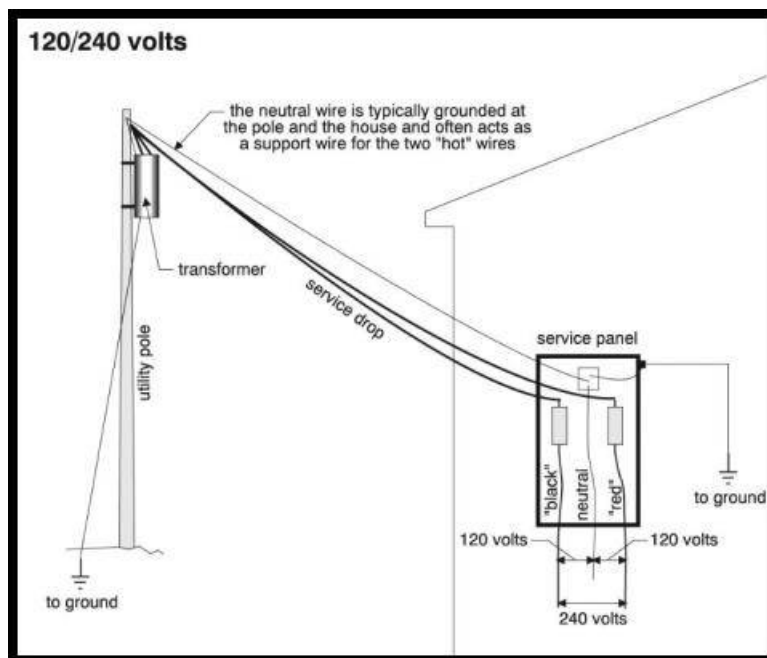
17.3 SYSTEM TYPE & VOLTAGE:

The home's electric service includes a 3 Wire System using both 110/220 volts.

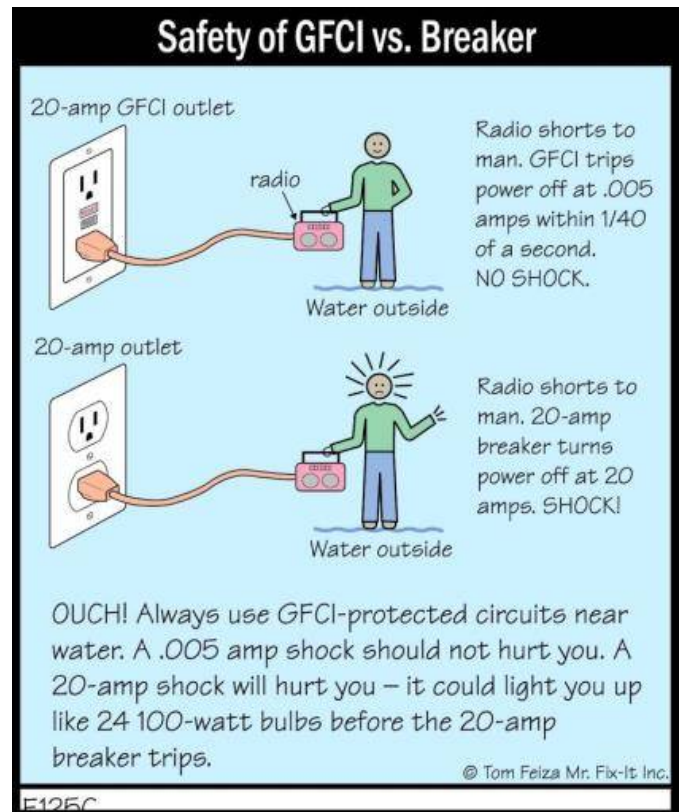
17.12 GFCI PROTECTION:

This home is partially equipped with the recommended GFCI protection. It is suggested that the remaining circuits be up-graded to include these desirable safety devices.

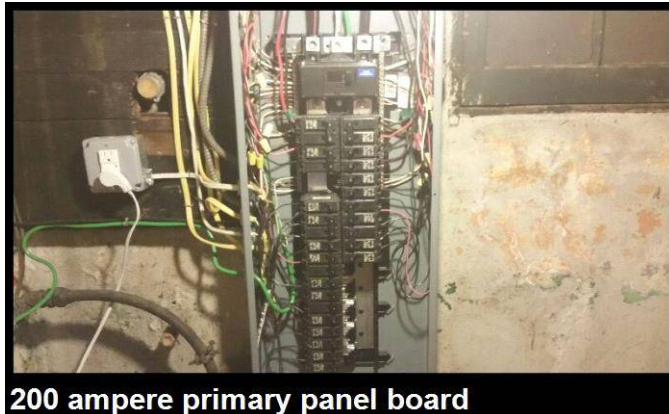
17.16 MAIN SERVICE EQUIPMENT:

The home has a 200 ampere primary panel board (load center). The main service line (feeder wires) are aluminum, which is satisfactory. Overcurrent protection is provided by circuit breakers located in the main panel.
